Metropolis – 8 W. Monroe St. Fan Coil Unit Replacement Program

Pages 4 - 10: Fan Coil Unit Investigation – Completed by Sunnyside Design Group

Sunnyside Design Group, Inc.

April 13, 2022

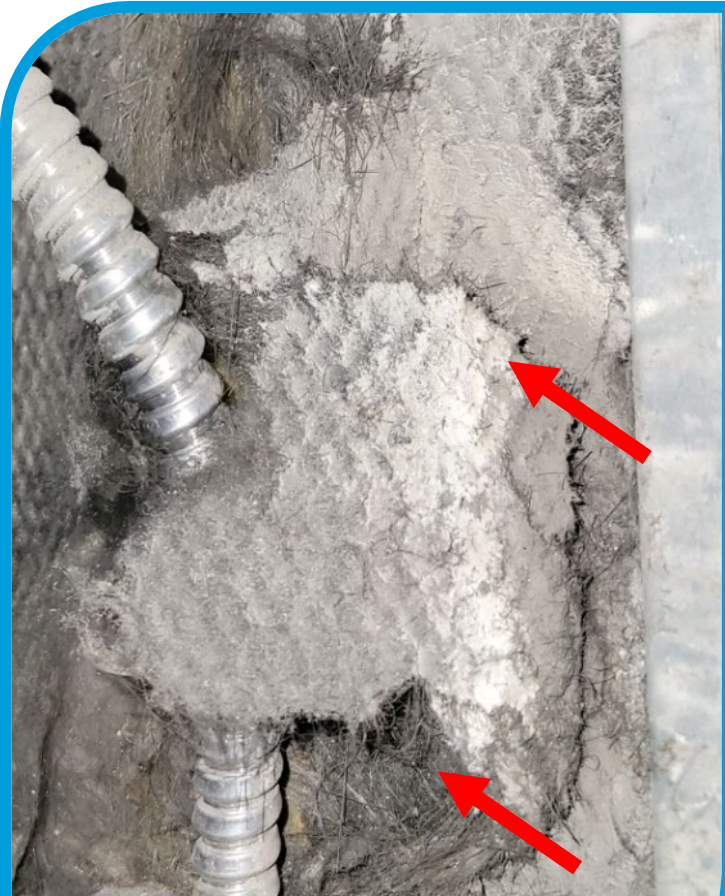
Side Cabinet Wall

Deteriorating fiberglass insulation

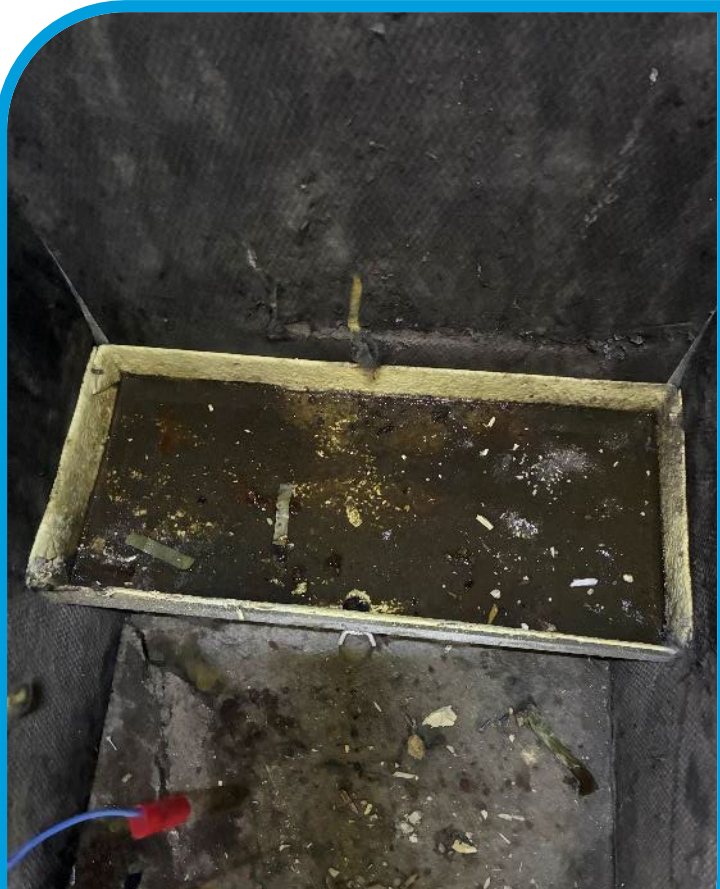
Drain pan

Increased **Flood Risk**

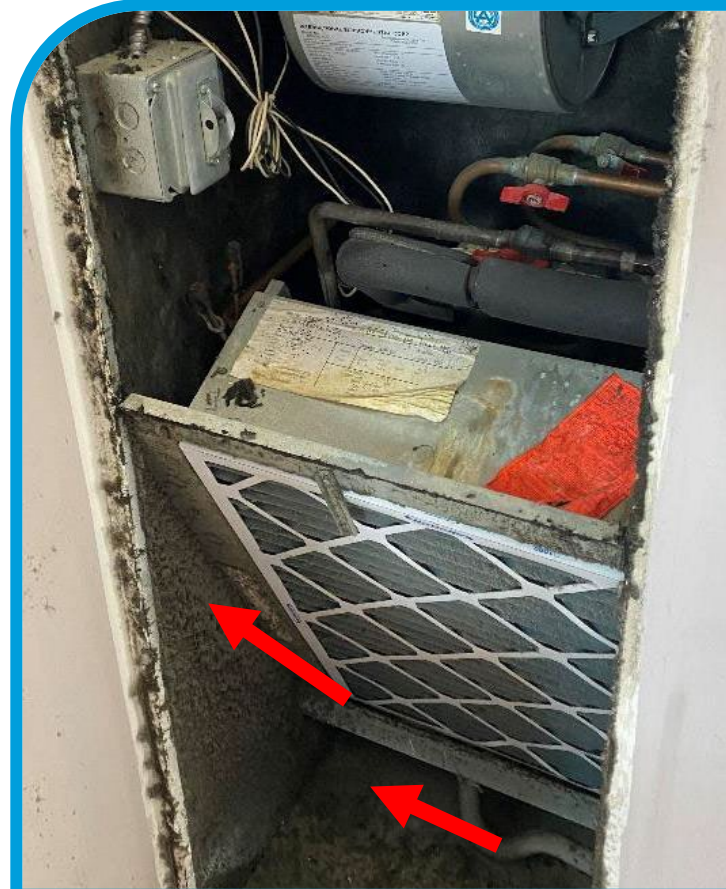
Dust Buildup

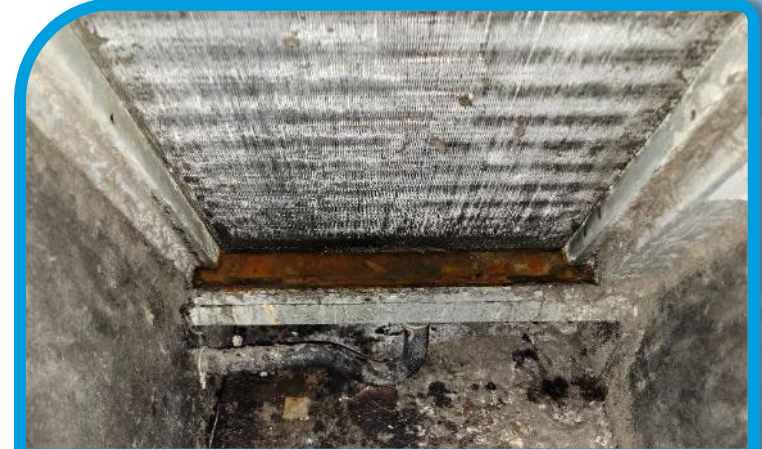
Drain pan compromised + Leak

Dust **build up**

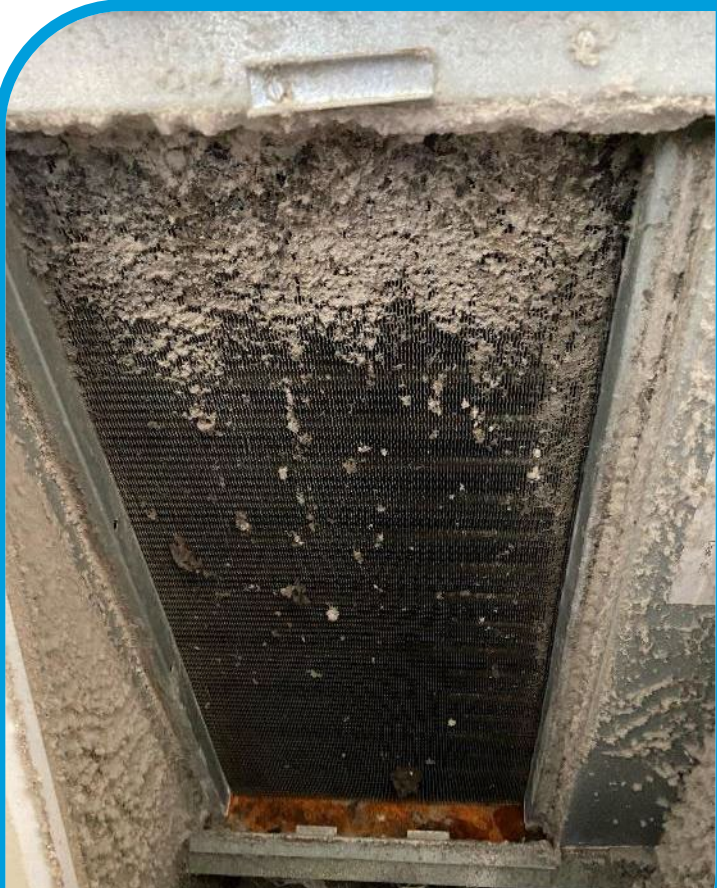
Clogged coil – **example 1**

Significant blockage

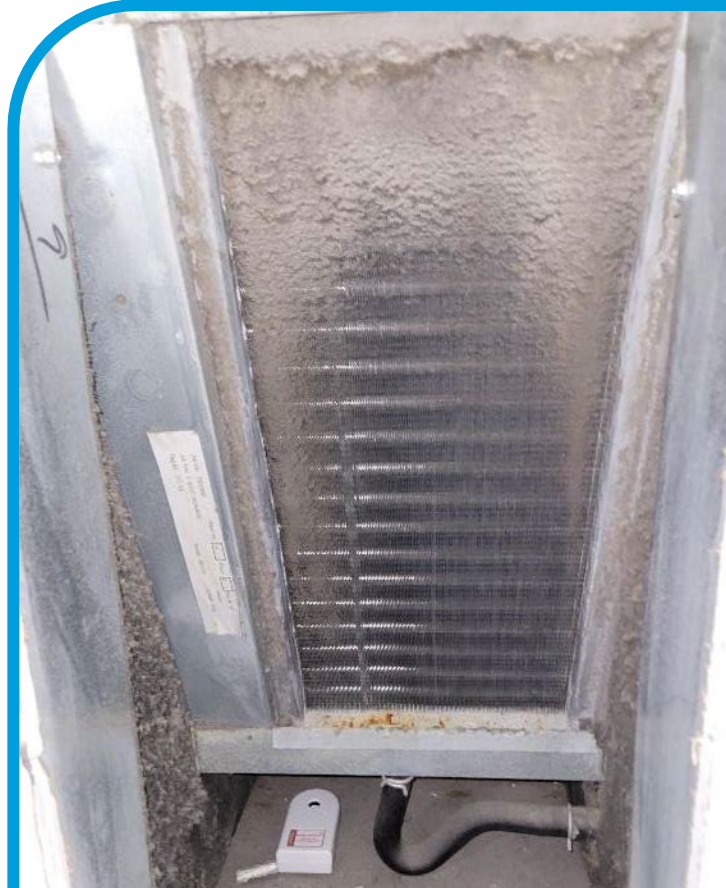
Significant blockage

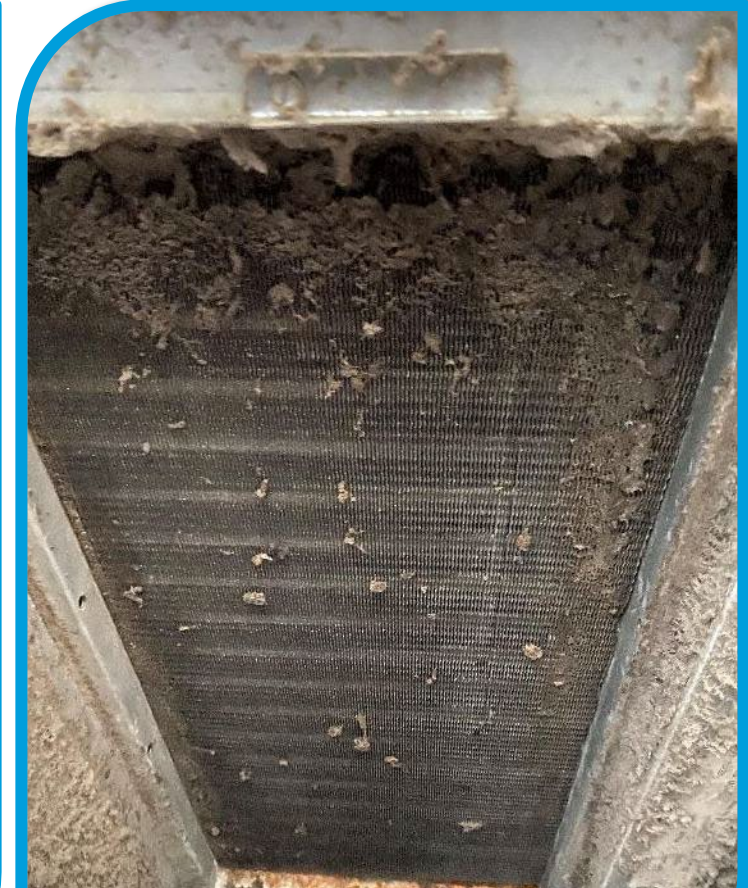
Significant blockage

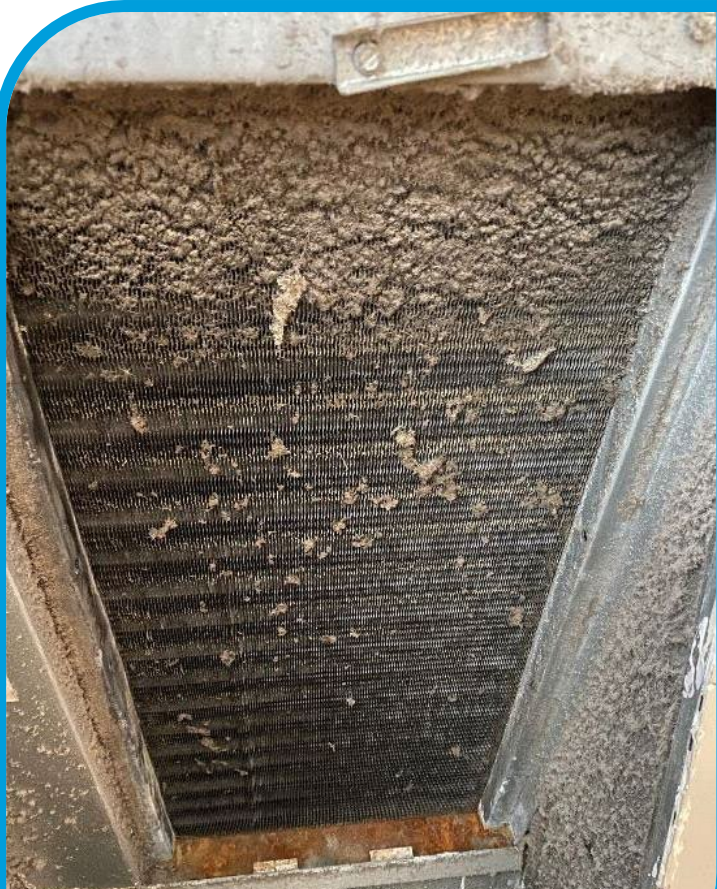
Clogged coil – **example 2**

Less air flow & drain clog risk

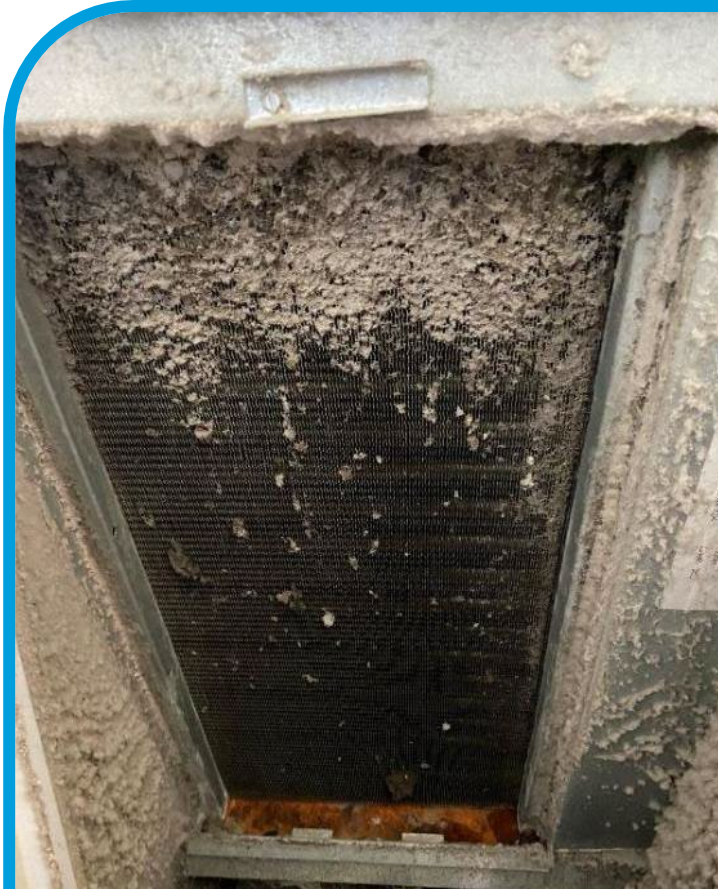
Less air flow & drain clog risk

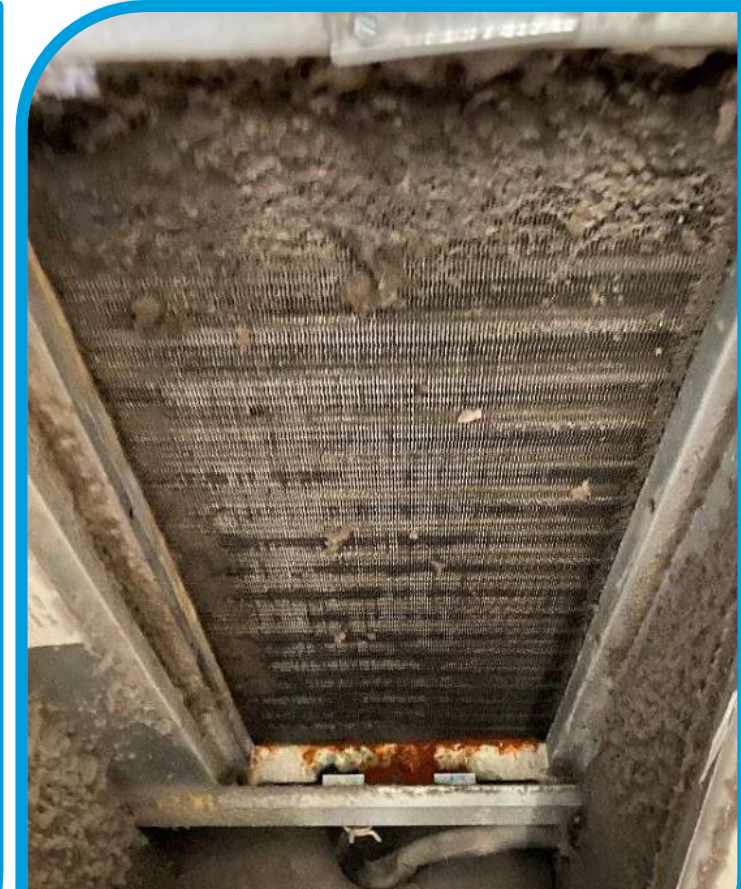
Less air flow & drain clog risk

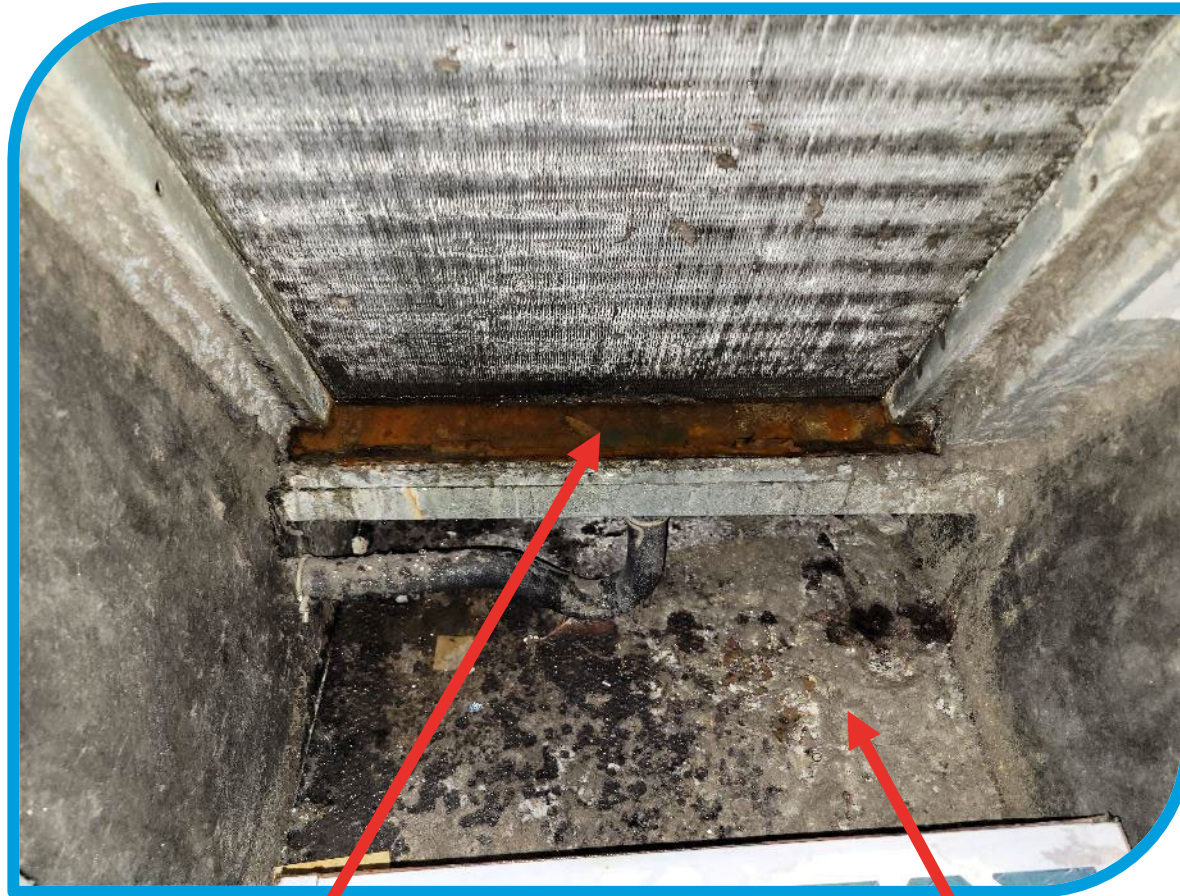
Flooding – example 1

Water overflowing from pan

Wet spots and mold growth

- The larger clumps of dust fall into the drain pan and eventually clog the drain line and cause a flood.
- Unilux's inspections found multiple units which were in the process of flooding. Management was notified immediately and rectified the issue.

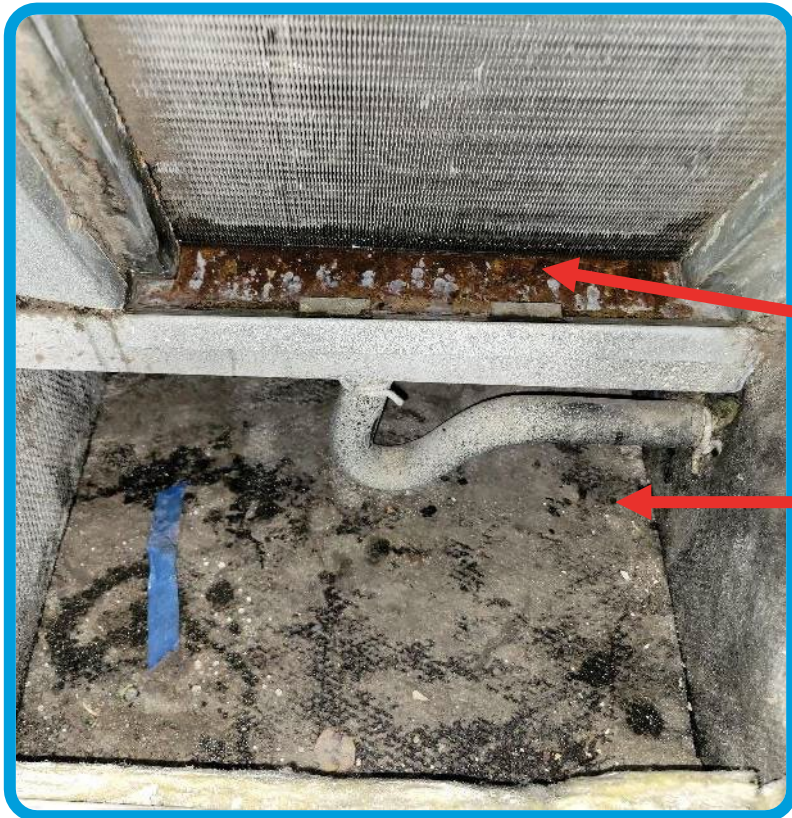
Flooding – example 2

- The larger clumps of dust fall into the drain pan and eventually clog the drain line and cause a flood.
- Unilux's inspections found multiple units the process of flooding. Management was notified immediately and rectified the issue.

Water overflowing
from pan

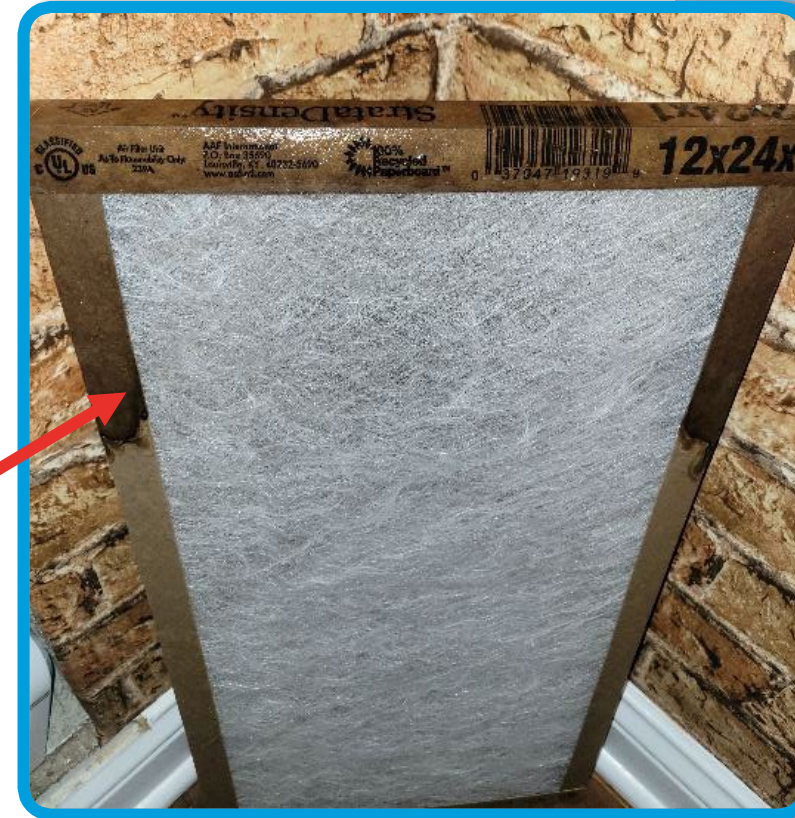
Water marks

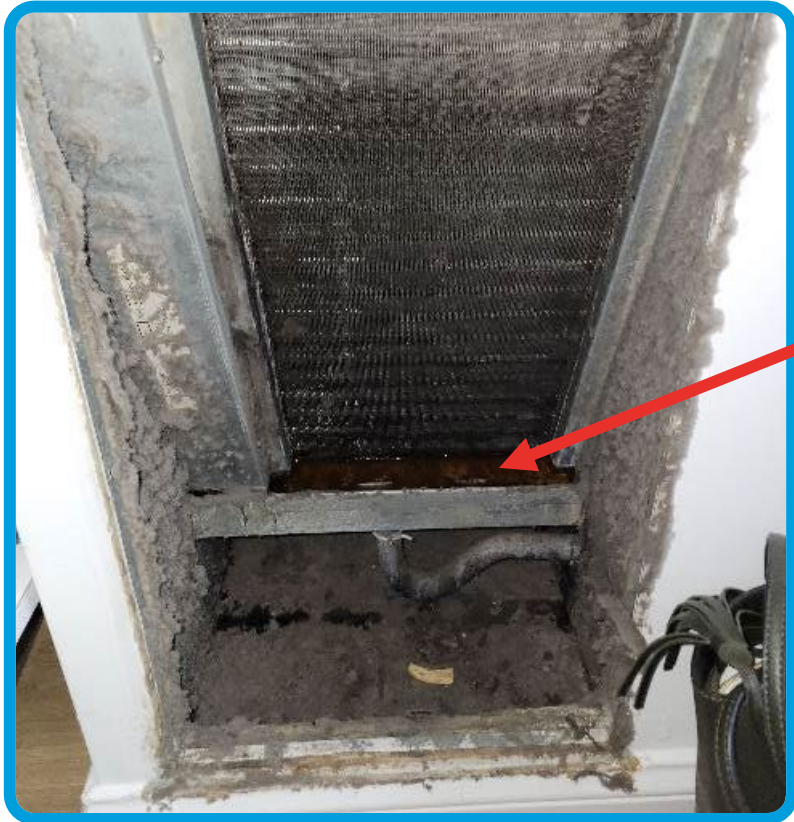
Flooding – example 3

- The larger clumps of dust fall into the drain pan and eventually clog the drain line and cause a flood.

Water overflowing
from pan

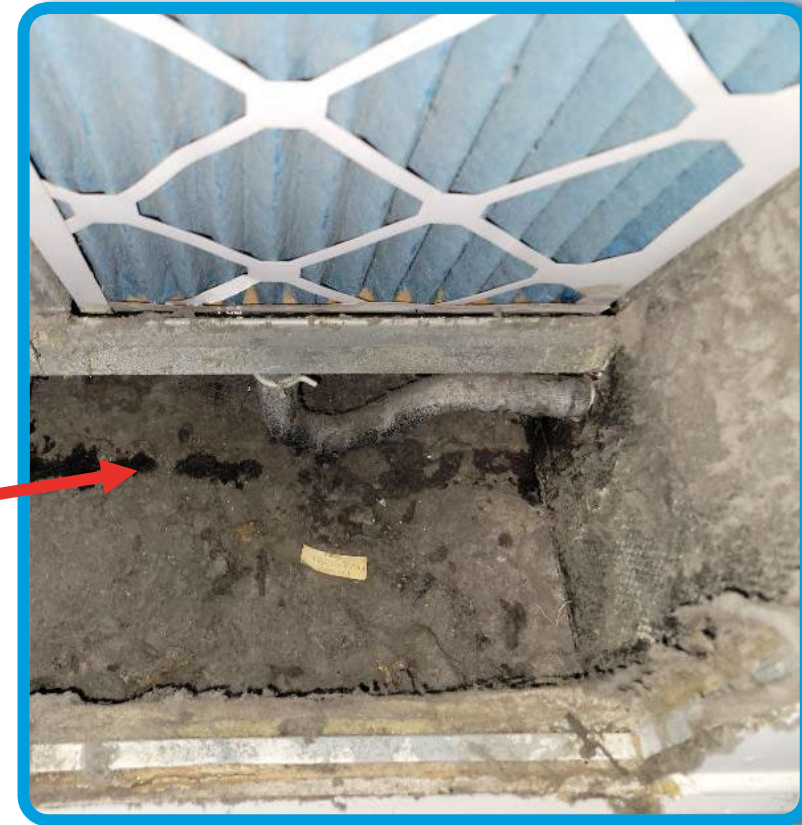
Water marks

Visible microbial growth
