Metropolis – 8 W. Monroe St. Fan Coil Unit Replacement Program

Pages 4 - 10: Fan Coil Unit Investigation – Completed by Sunnyside Design Group

Sunnyside Design Group, Inc.

April 13, 2022

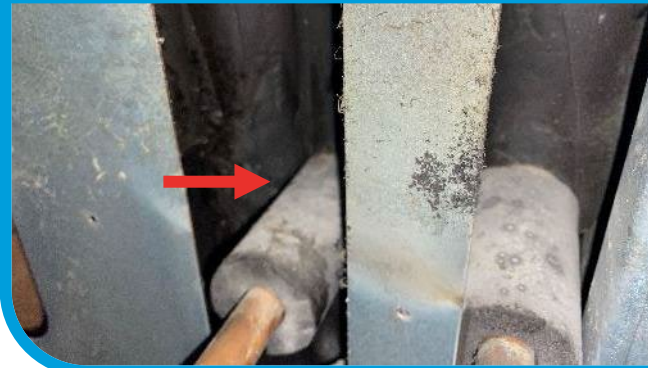
Insulation peeled back
