Fan Coil Unit Replacement

Many owners have been looking to replace their fan coil unit(s) (FCU) and the Board of Managers, in order to obtain bulk pricing, has selected Unilux as the contractor to replace the (FCU) in your home.

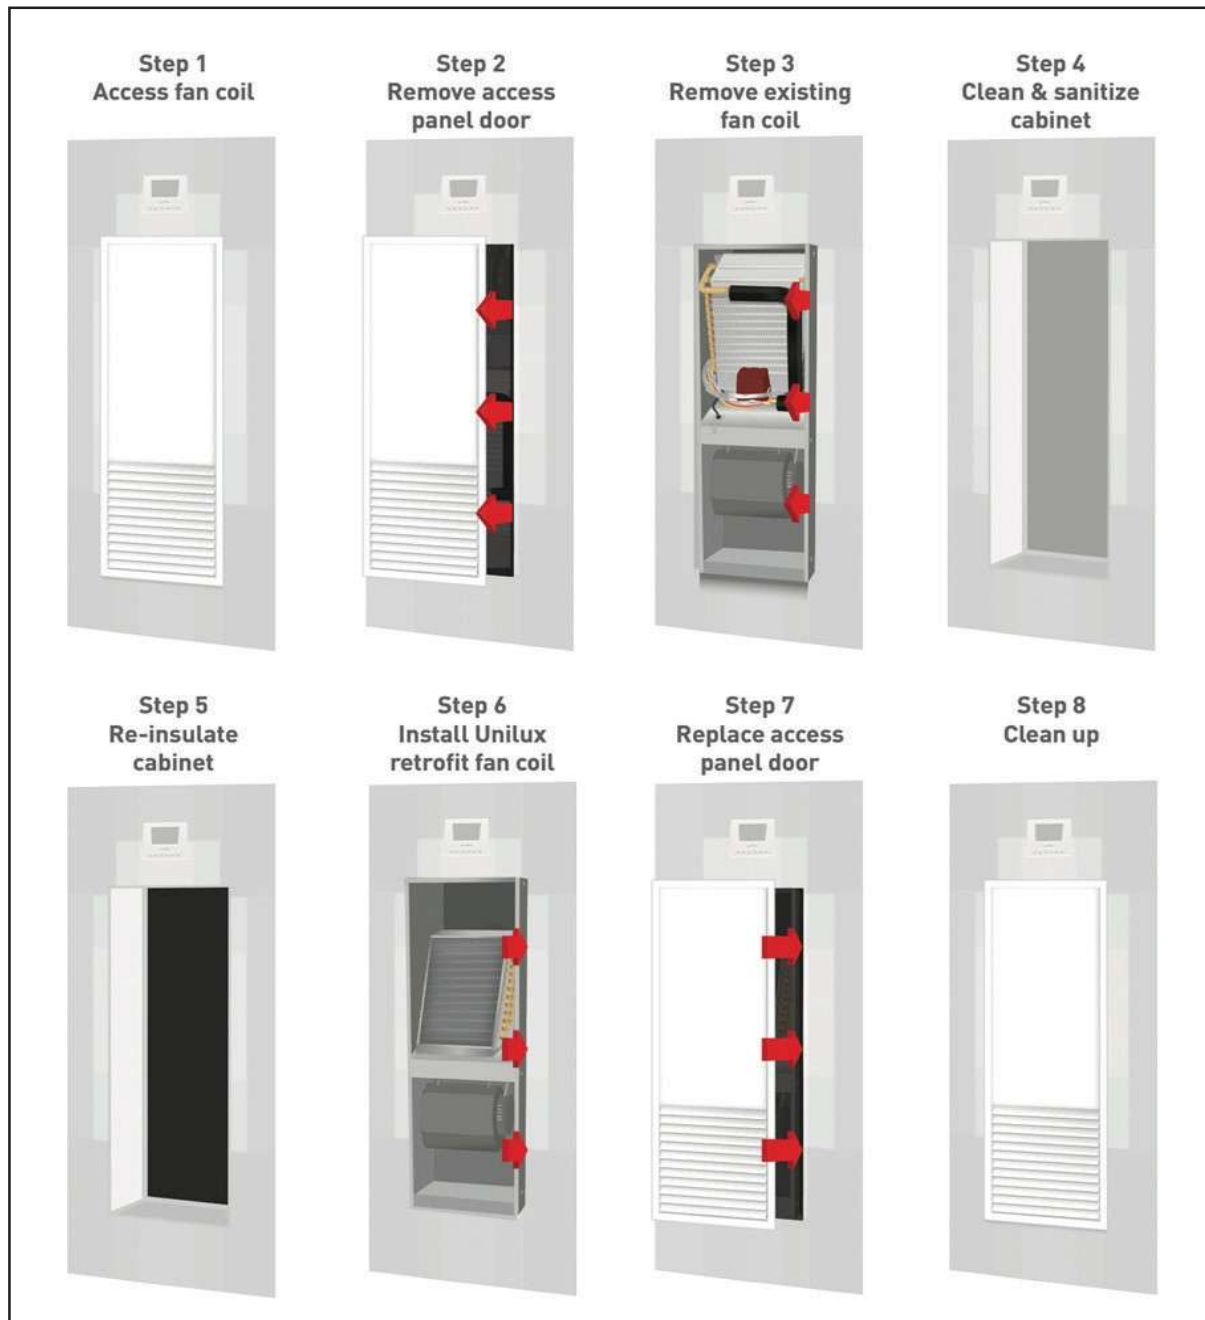
The Unilux retrofit insert is designed to minimize the disturbance to the resident but still meet the same standards in quality and longevity of the original fan coils installed during the building's construction.

The retrofit insert unit replaces all the functional components of the fan coil without damaging the existing drywall, trim, or paint.

- Install closed-cell anti-microbial foam insulation along cabinet walls.
- Supply and install Unilux retrofit fan coil unit to match existing capacity.
- Water Coil: 4-pipe; 1/2" copper with corrugated aluminum fins; manual air bleeder.
- All stainless-steel chassis.
- Drain pan fully welded and positively sloped to center.
- ECM motor, 3-speed fan, flood sensor, ecobee smart thermostat.
- 3-way valve and actuator.
- Reconnect system to power and water supply, and test.
- Change isolation valves.
- 2-year warranty (optional 5-years).
