Metropolis – 8 W. Monroe St. Fan Coil Unit Replacement Program

Pages 4 - 10: Fan Coil Unit Investigation – Completed by Sunnyside Design Group

Sunnyside Design Group, Inc.

April 13, 2022

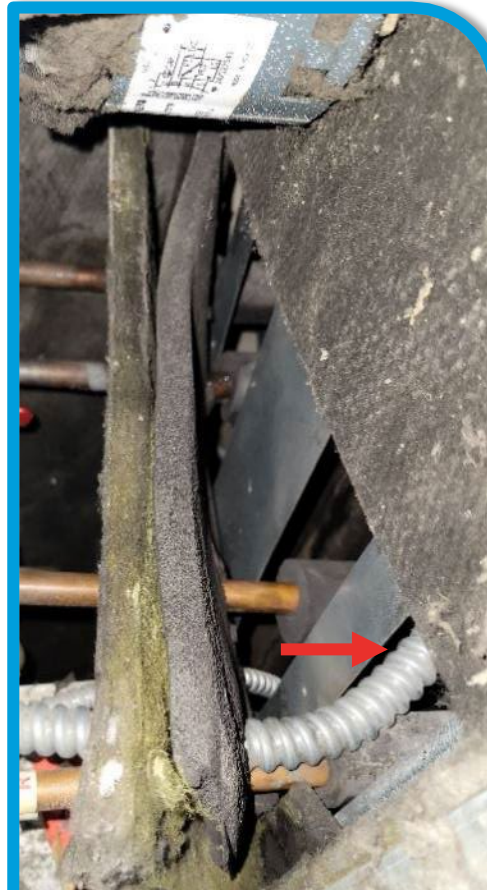
Open cavity

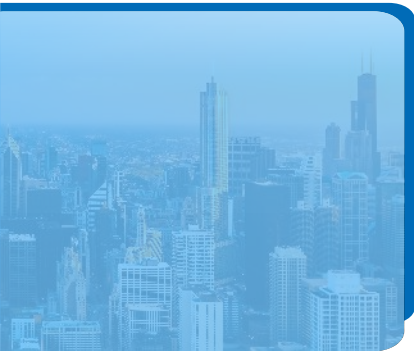
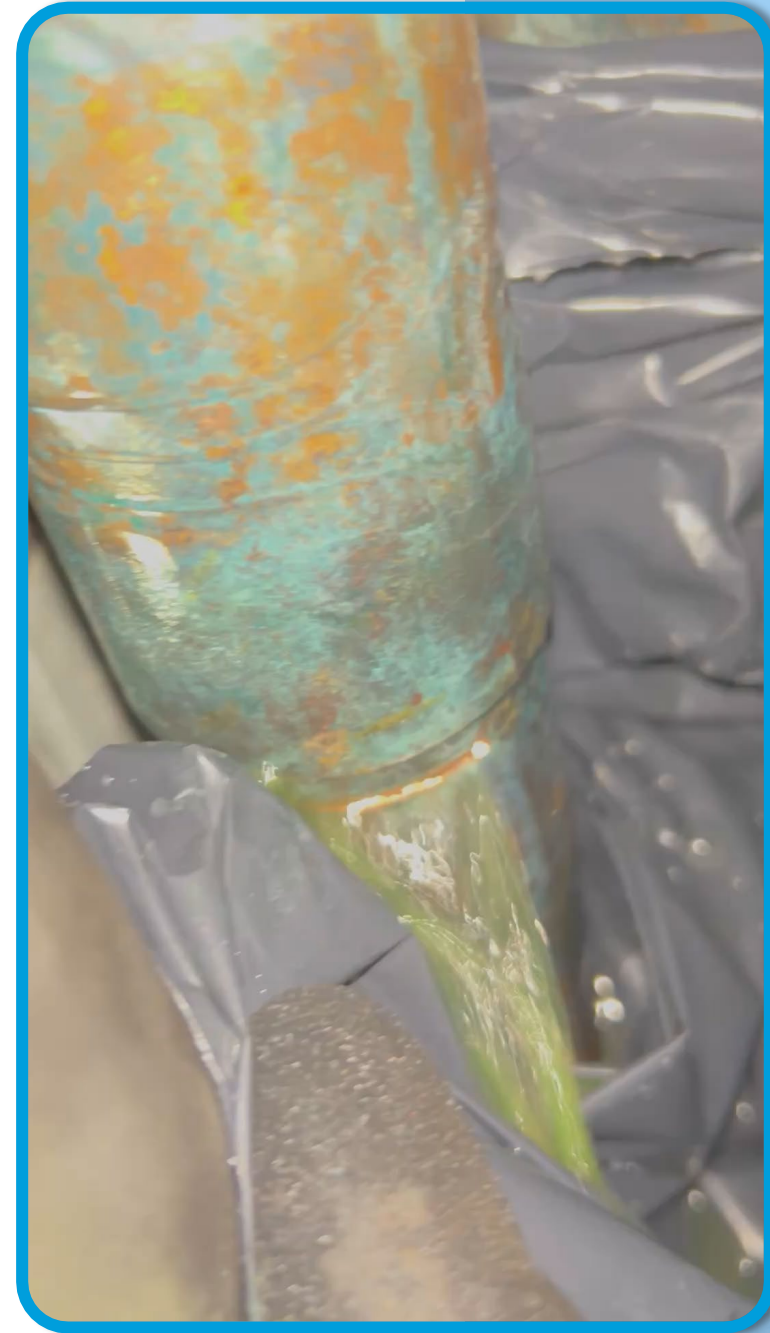
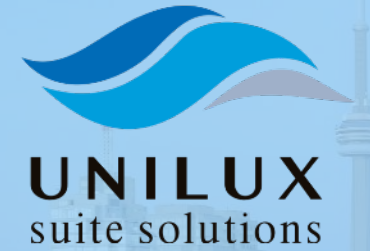
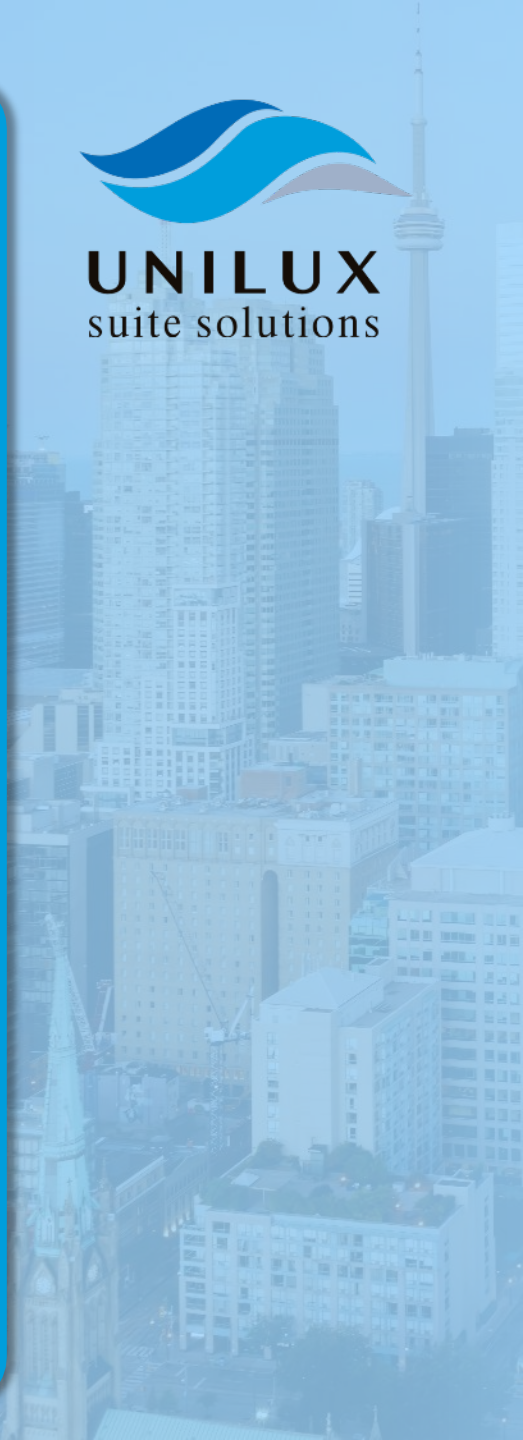
Increased **Flood** **Risk from existing** **Riser Ts**

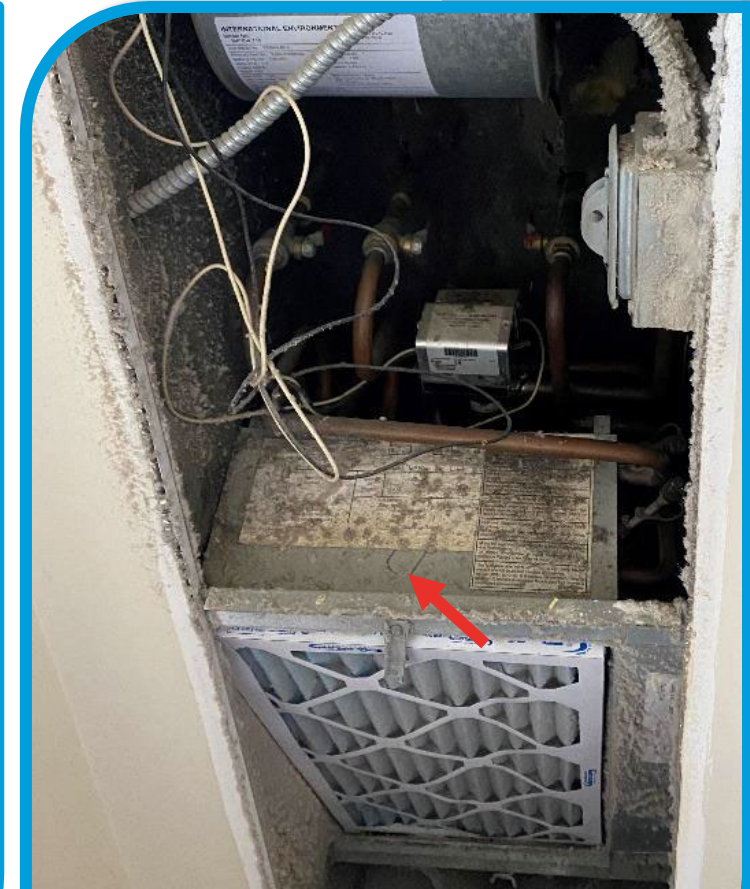
Coil housing

Clogged coil – **example 1**

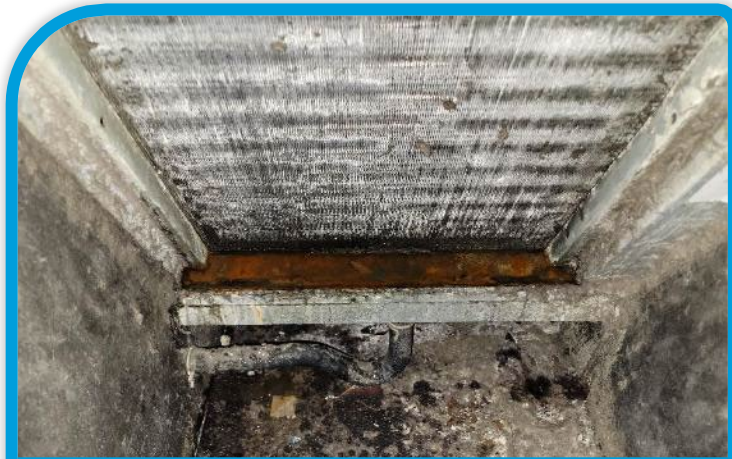
Bottom of Cabinet

Visible microbial growth
